ENEWETAK FACT BOOK

(A RESUMÉ OF PRE-CLEANUP INFORMATION)

COMPILED BY
WAYNE BLISS
U.S. ENVIRONMENTAL PROTECTION AGENCY

COMPILED 1977
PUBLISHED SEPTEMBER 1982

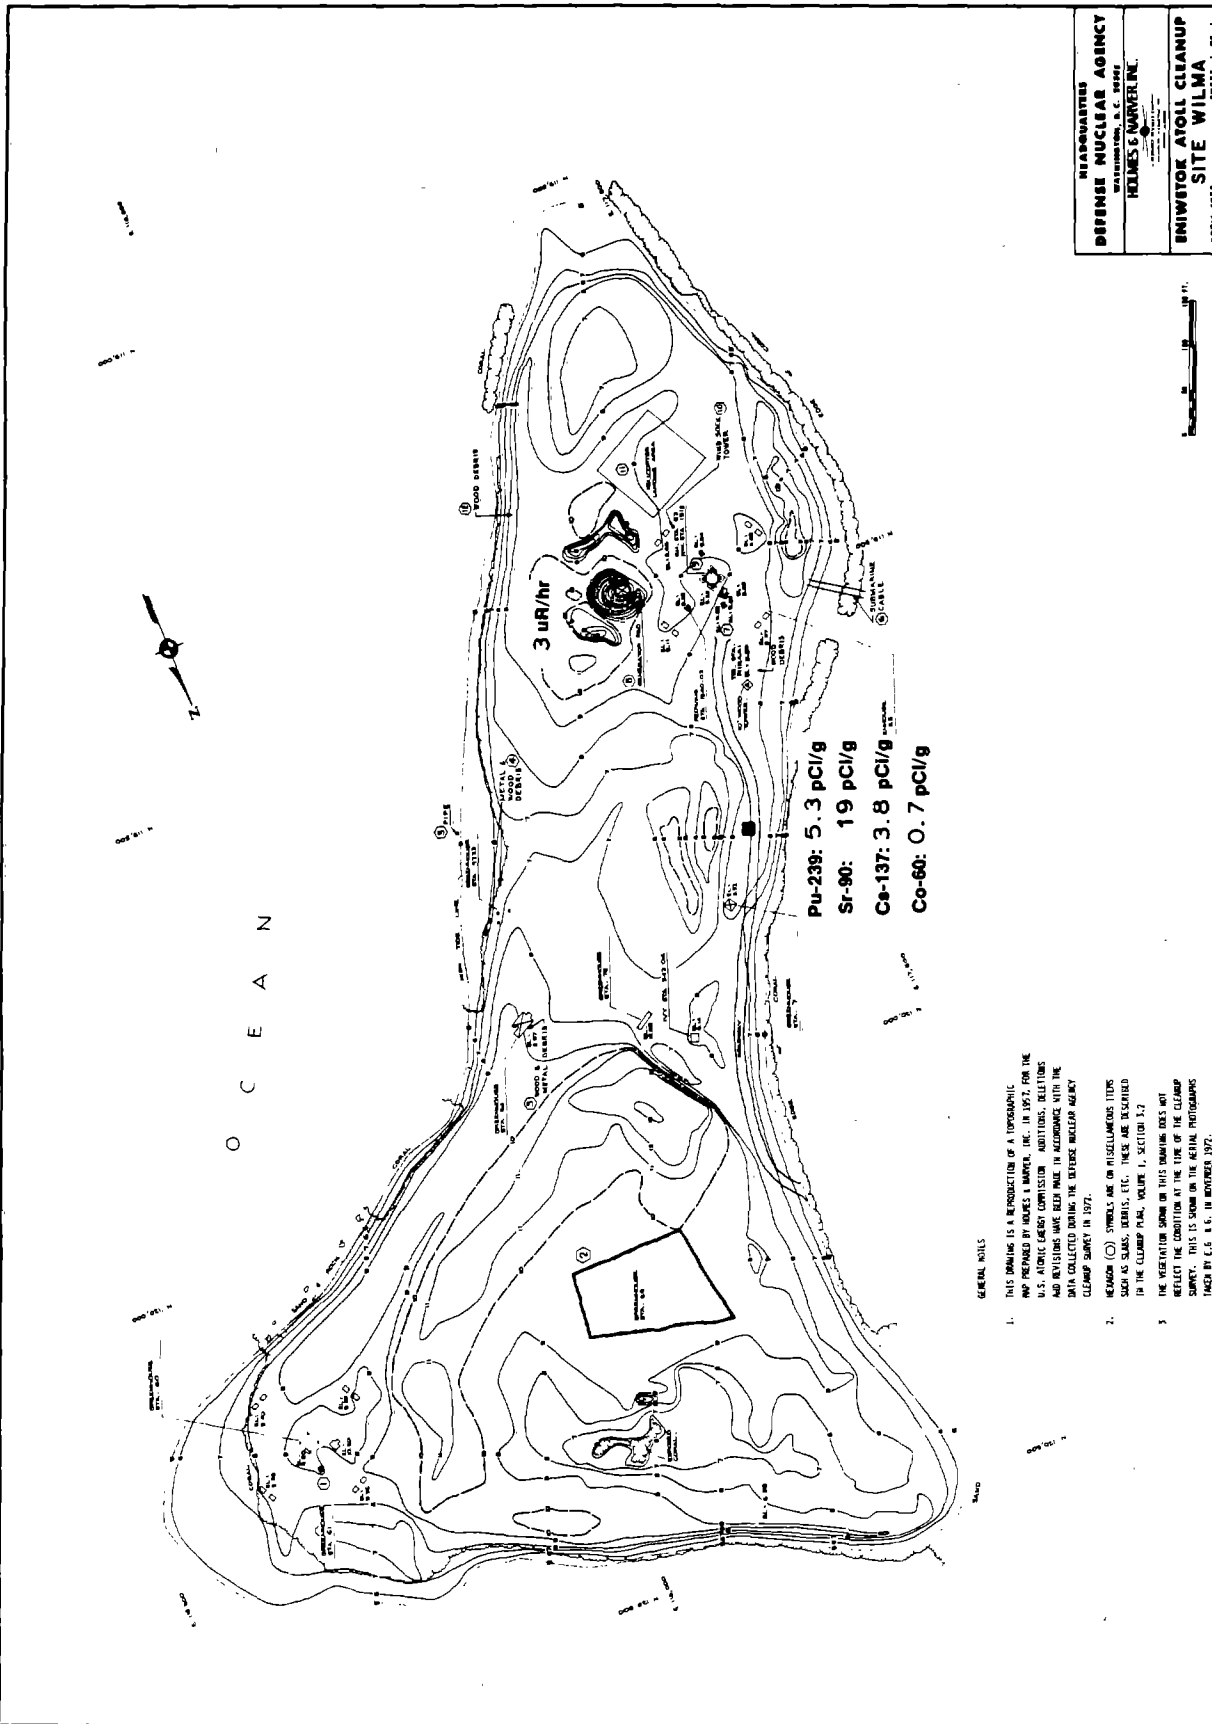
FIGURE 64. SITE WILMA

Eight scientific stations with a moderate amount of debris remain on WILMA (Figure 64). WILMA has no surface zeroes and ranks 21st among islands of the Atoll with 294 R/h accumulated H+1 hour exposure rate.

No radioactive material burial sites are known to exist on WILMA.

CASE 3: BIRDS, EGGS, SUBSISTENCE & COMMERCIAL AGRICULTURE
